INSPECTING THE Hone Quarry Dam Conduit Structures

In 2010, Hurt & Proffitt (H&P) performed a dam breach and inundation study for the Hone Quarry Dam, which was classified as a High Hazard Dam. Originally designed for flood control in 1965, the impoundment is a 94-foot tall earth embankment dam. It is located on Hone Quarry Run, a tributary to the North River, in Rockingham County, Virginia near the Town of Bridgewater. The study determined that the dam had insuffi-

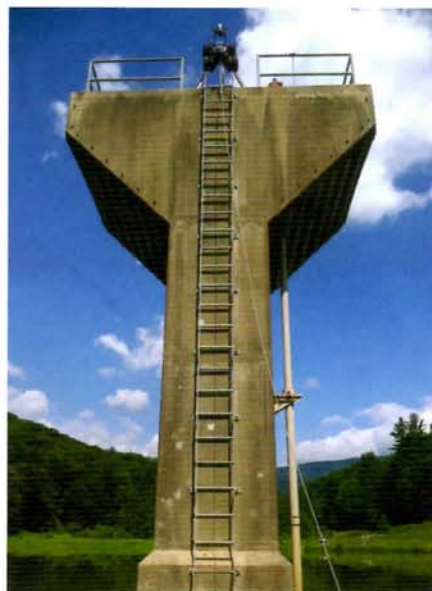
FIGURE 3: Hoisting inspection equipment onto riser structure
